**WEDGEWIRE SCREENS: ADDITIONAL DESIGN FOR
[REDACTED] CONFIGURATION AT
SCHILLER STATION
PORTSMOUTH, NEW HAMPSHIRE**

Submitted to:
GSP Schiller LLC

Submitted by:
Enercon Services, Inc.
7677 Oakport Street, #950
Oakland, CA 94621

June 21, 2021

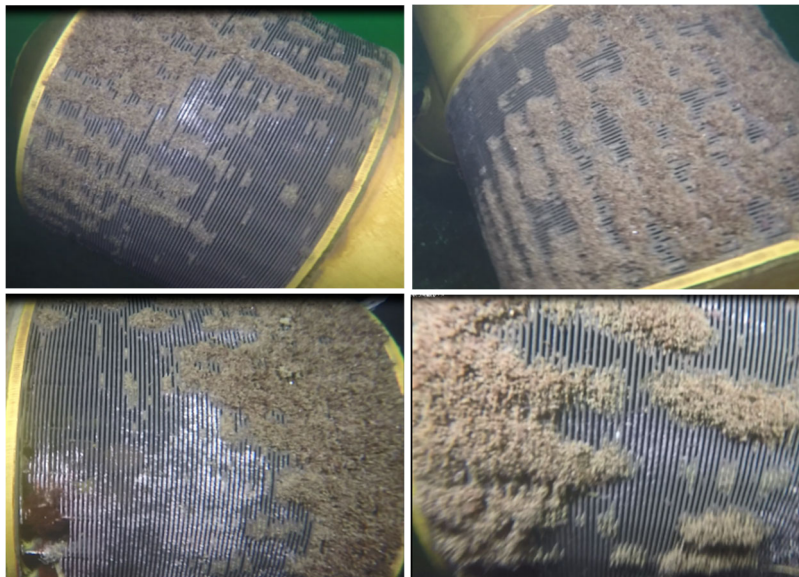
The fouling was comprised of high-density siltation and biogrowth which accumulated along the axial support bars which expanded to the remainder of the screen surface. The fouling observed on the pilot wedgewire screens was assumed to be due to mechanical compaction of the fouling deposits against the axial support bars and between the circumferential wire rings. Though the construction material used in the construction of the pilot wedgewire screens is anticorrosive and biogrowth resistant, the compacted fouling deposits were believed to have provided a host surface on which biogrowth occurred. It was noted that, while biogrowth occurred where fouling deposits collected, there was a negligible amount of fouling on the risers, flow diverters, and conical end closures. The largest amount of fouling observed during the site-specific fouling test encompassed 36% of the 0.8mm test wedgewire screen assembly. Underwater imagery of the observed fouling is provided in Figure 2.

Figure 2. Underwater imagery of observed biofouling.

After performing the Schiller Station site specific study, it was found that several critical parameters did not meet requirements for sustainable operation at Schiller Station. A significant amount of fouling and damage to the pilot wedgewire screens were observed during the test period of continuous operation. The test screens were initially installed in December of 2018 and were retrieved in January of 2020. In the duration which the screens were submerged, the combined effects of the accumulated fouling and screen damage resulted in a loss of entrainment exclusion effectiveness.

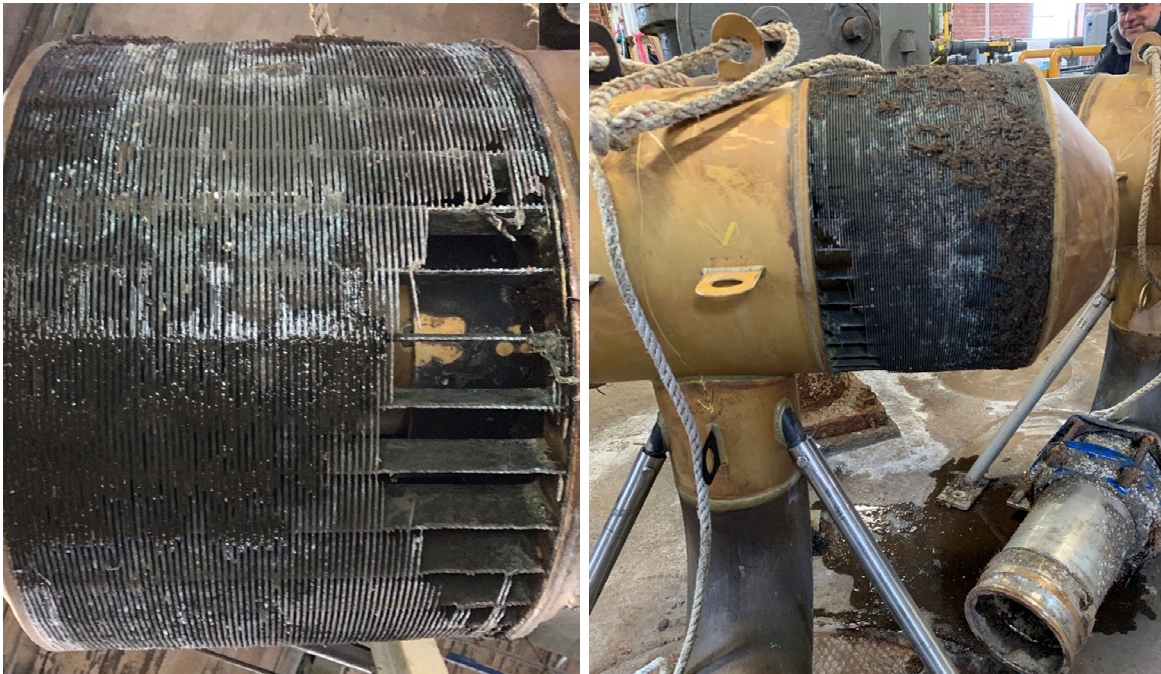
During the duration of the site-specific pilot test, an increasing severity of damaged surface area was observed. The damage was initially localized on the riverbed facing sides of the assemblies and rapidly expanded to a large opening in the wire screens. At the conclusion of the study period, an estimated 19.25% of the surface area of the 0.8mm test wedgewire screen assembly was exposed. The damaged areas of the 0.8mm test wedgewire screen assembly measured as wide as 3.5 inches. This would allow for fish, shellfish, and debris larger than the 0.8mm slot width to be withdrawn through the cylindrical wedgewire screen. Due to the hydraulic effects associated with the screen damage, it is estimated that 44.5% of the water withdrawn by the test wedgewire screen assembly would bypass the narrow slots under clean screen conditions. The amount of bypassing flow would be compounded by the amount of undamaged surface area clogged by fouling. The bypass of the screens due to damage and the removal of screens for maintenance would result in a reduction in entrainment exclusion effectiveness. Imagery of the damaged portions of the test wedgewire screen assembly is provided in Figure 3.

Figure 3. Imagery of damaged portions of the test wedgewire screen assembly.

Over half of the 0.8mm wedgewire screen assembly surface area was affected by either fouling or damage. To ensure observed fouling and damage do not impact the normal operations of Schiller Station, a full-scale installation of cylindrical wedgewire screens must be deployed in a way

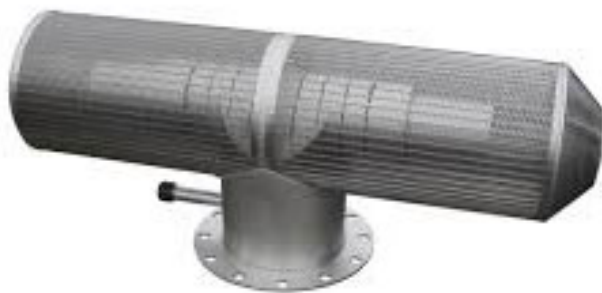
Figure 6. Johnson passive intake half-screen (left) and T-screen (right).

The functional requirements of two 96" half screens can be achieved with 6 full 72" cylindrical T-shaped screen. Therefore, to provide for frequent inspections and continuous operation, this configuration utilizes 72" cylindrical T-screens.

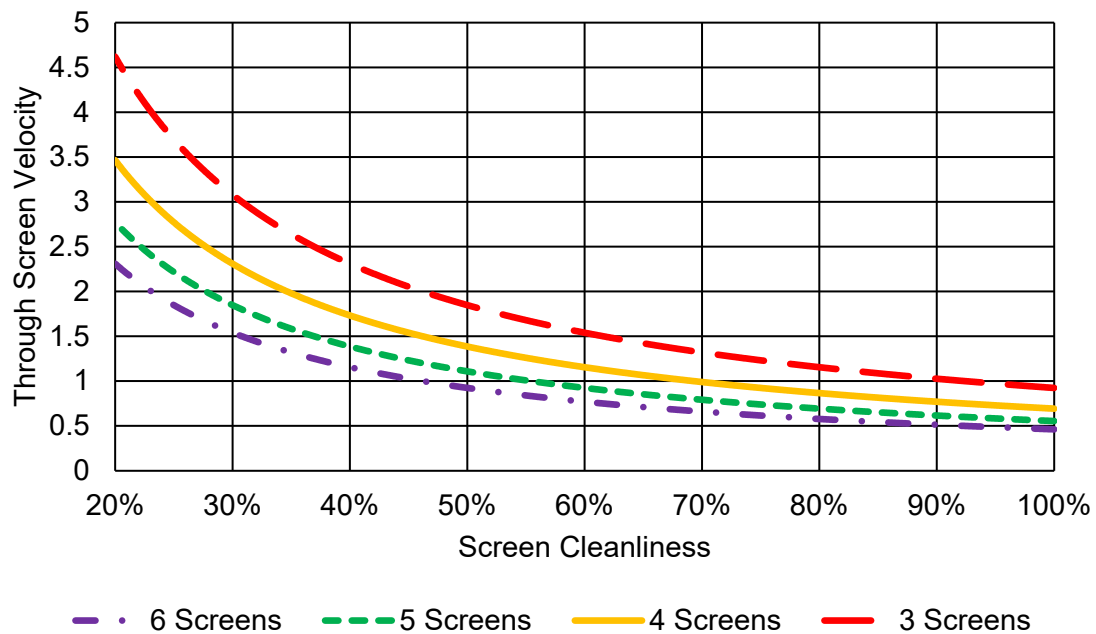
At the most recently calculated actual intake flow [REDACTED], the through screen velocity with six fully clean screens would be 0.264 ft/s. The estimated through screen velocity provided by Johnson Screens was calculated under clean screen conditions. If, as observed during the site-specific pilot study, significant biofouling was to occur and portions of the screen area became blocked by debris, the total screen open area could be reduced. This area reduction would lead to increased actual through screen velocities. Estimated through screen velocities at corresponding intake flow rates and screen cleanliness are shown in Figure 8. When Unit 4, Unit 5, and Unit 6 are not concurrently operating, the extraneous cylindrical wedgewire screens could be stored above the surface of the water to reduce biofouling and potential damage. Estimated through screen velocities at design intake flow (DIF) with corresponding quantities of operating screens and screen cleanliness are shown in Figure 9.

Figure 8. Plot of estimated through screen velocities at 3-year AIF with corresponding quantities of operating screens and cleanliness

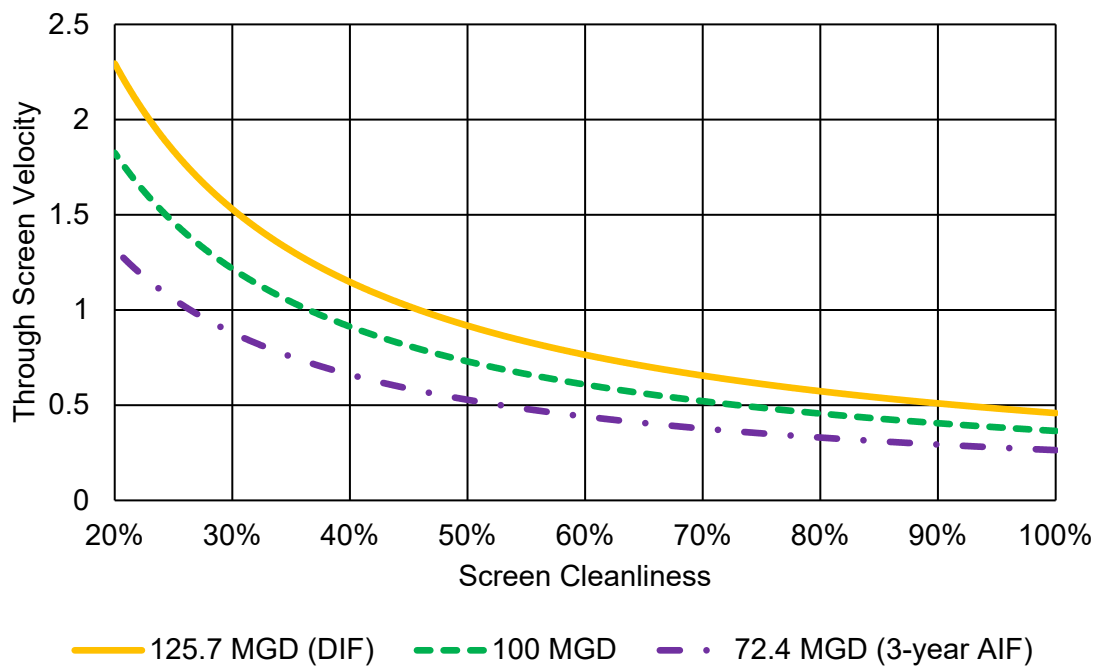
Figure 9. Plot of estimated through screen velocities at DIF with corresponding intake flow rates and screen cleanliness.
